Operation TEAPOT

Project 31.2

DAMAGE TO COMMERCIAL AND INDUSTRIAL BUILDINGS
EXPOSED TO NUCLEAR EFFECTS

Bruce G. Johnston

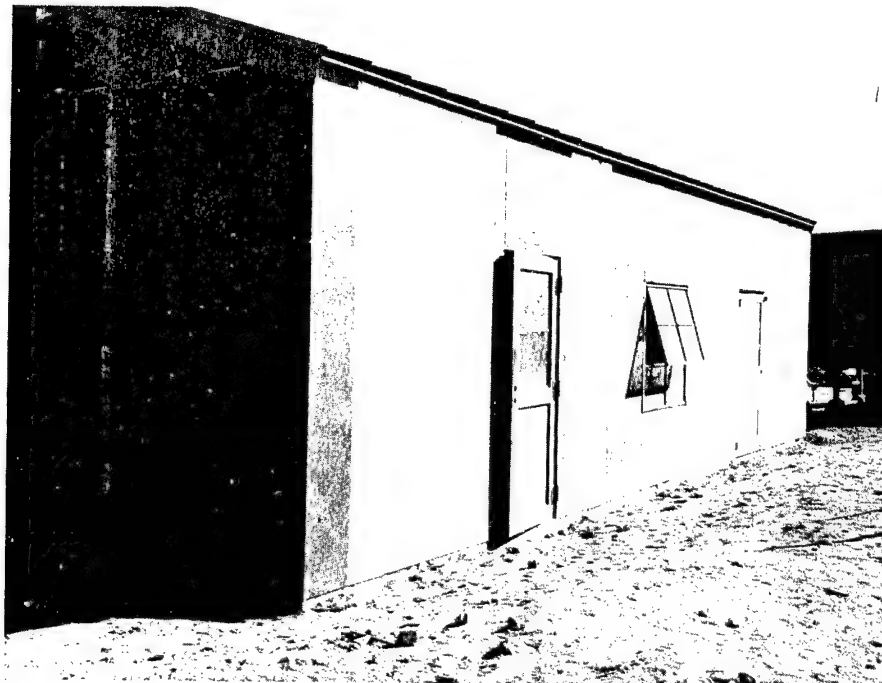
Fig. 1.22—Armco Building 31.2-d1 repaired after unexpected test.

after repair of the north wall damage, was previously illustrated in Fig. 1.22. Appendix B provides an analysis of the dynamic behavior of Building 31.2-d1.

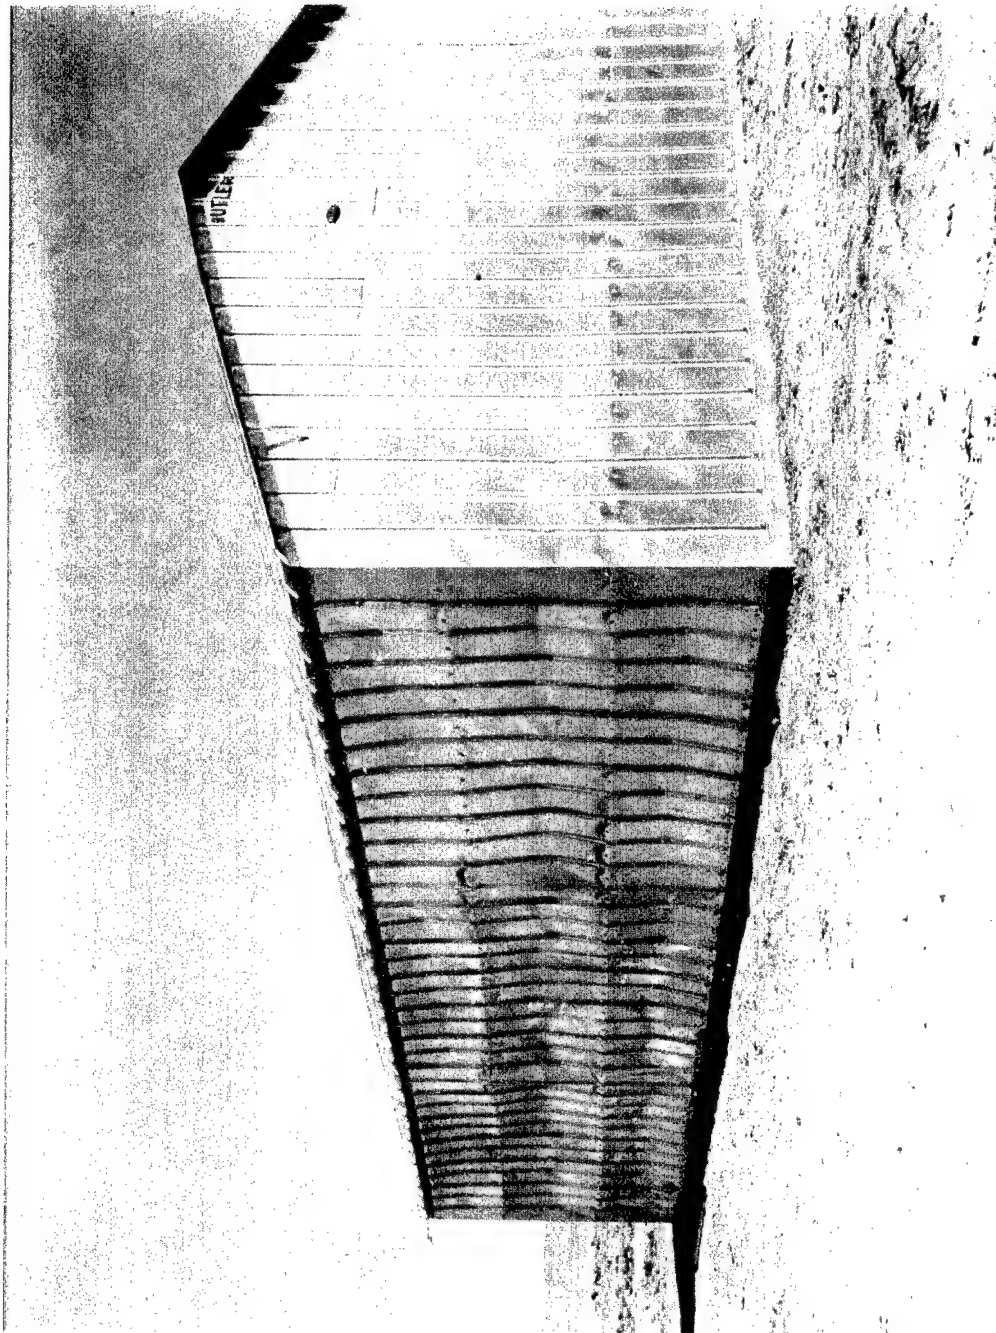
Figure 2.1 gives a general indication of the damage from the unexpected test to the north wall of Reynolds-Butler Building 31.2-a1, which was left with permanent inward deflections up to 5 in. The offset measurements, as recorded at the site, are tabulated in Fig. 2.2 for both the unexpected and planned tests. The two wall girts were bent in along with the paneling, and the bolt heads of the panel fasteners were generally pulled through the sheeting. Washers had been omitted along these two lines of bolts, and hence no definite conclusion can be made as to the probable extent of pull through if they had been included. The roof sheeting was left with downward permanent sets, especially in the span immediately adjacent to the eaves, where the permanent deflections, as shown in Fig. 2.3 and recorded in Fig. 2.2, were measured up to 3 in. The roof purlins were not deformed appreciably. The interior view of the wall (Fig. 2.4) shows how twisting of the girts occurred with measured values up to 43°. It is also of interest to note the imprint of the wind-bracing ties on the wall paneling, indicative of the initial deflections that were experienced. A dynamic analysis of wall behavior in both the unexpected and planned tests is provided in Appendix A.

As shown in Fig. 2.1, the panels on the west end of the building suffered very little permanent deformation. The unexpected test involved a moderate northeast exposure, and at the east end, as indicated in Fig. 2.5, the panels were bent inward to a degree comparable with those on the north side. This picture was made during the process of repair, with damaged north and south wall panels removed but with the bent and twisted wall girts still in position.

Fig. 2.1 — General view of north and west end walls, showing damage from unexpected test to Reynolds-Butler Building 31.2-a1.

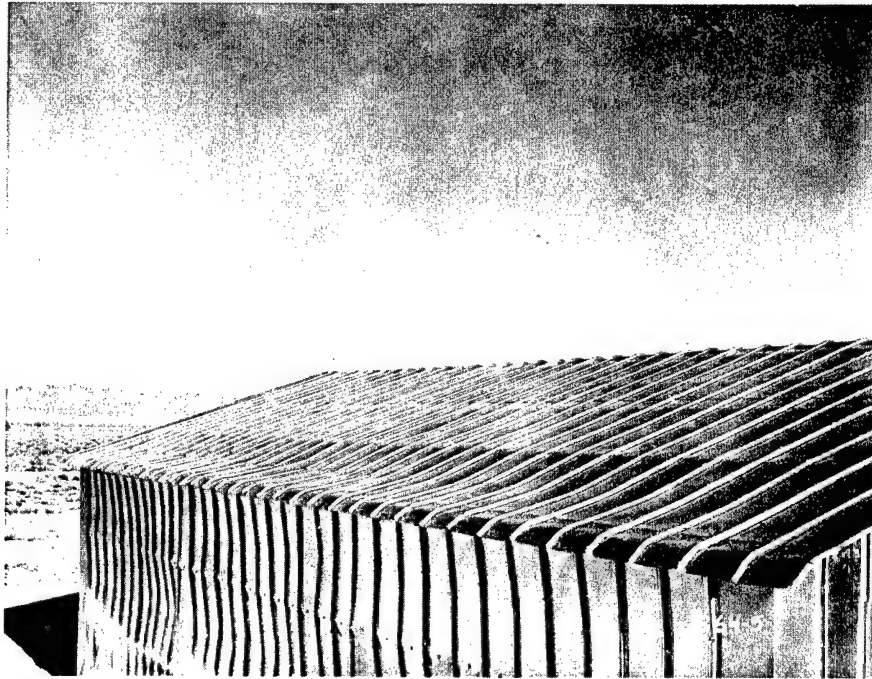
Fig. 2.3 — Damage to roof of Reynolds-Butler Building 31.2-a1 from unexpected test.

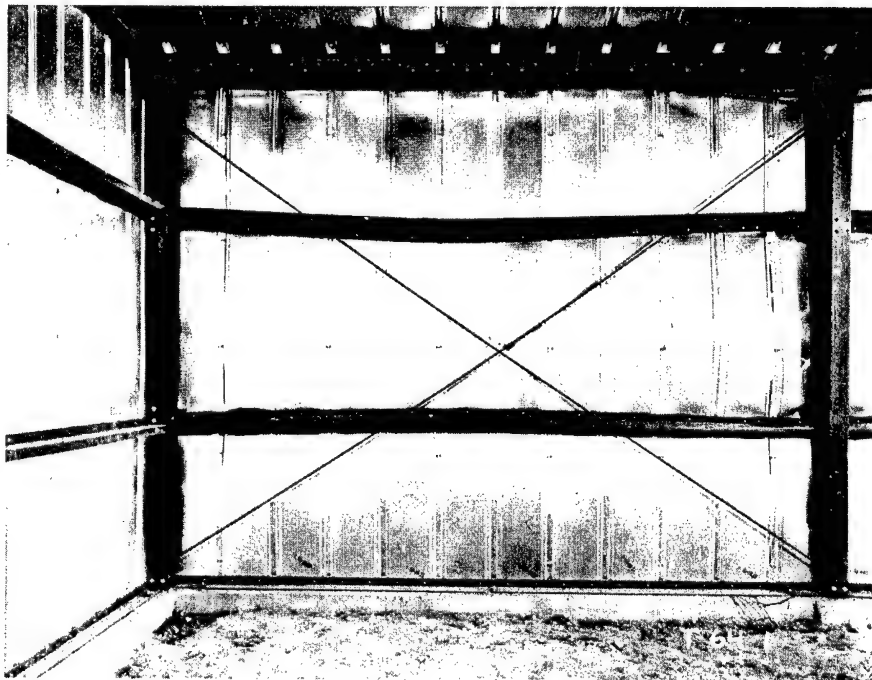
Fig. 2.4 — Interior view of damage to north wall in Reynolds-Butler Building 31.2-a1 from unexpected test.

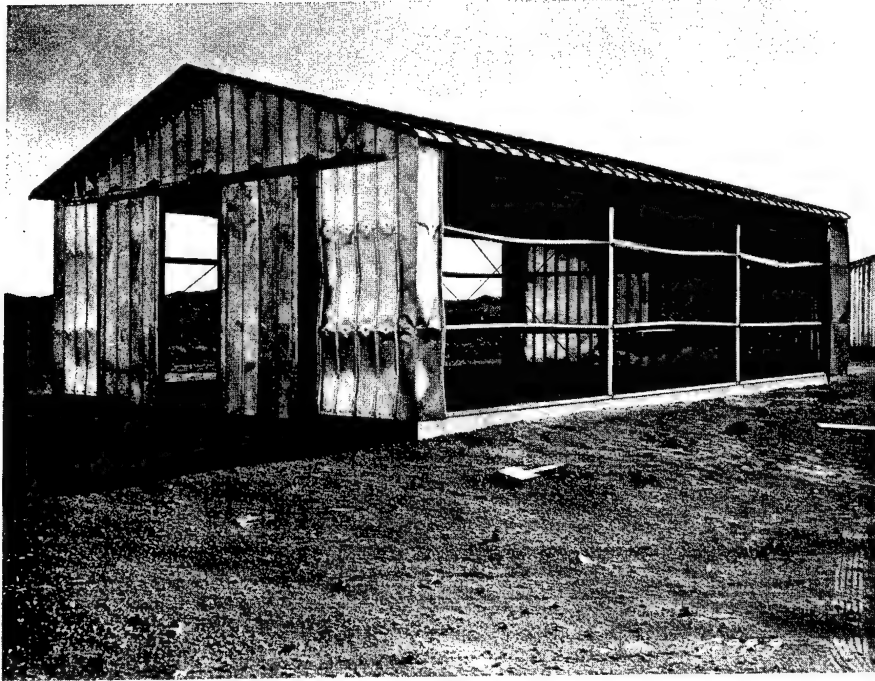
Fig. 2.5—North and south sides of Reynolds-Butler Building 31.2-a1 during repair of damage from unexpected test.

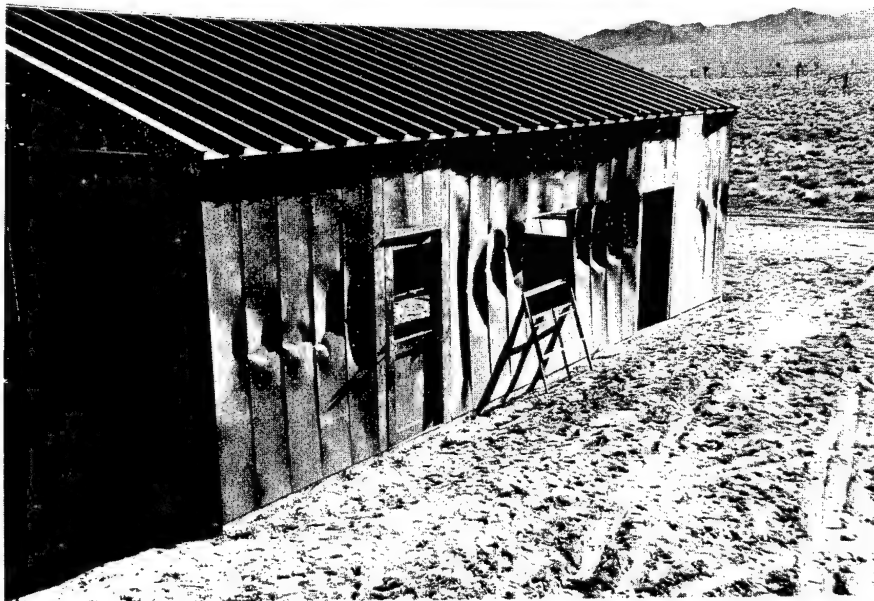
Fig. 2.6—Damage to north walls of Armco Building 31.2-d1 from unexpected test.

Permanent deflections along the north side of Armco Building 31.2-d1 are shown in Fig. 2.6 and are recorded in Fig. 2.7. The first five wall panels on the east and nearest the blast origin were damaged to a lesser extent. Maximum permanent deflections of the north wall, amounting to 4.8 in., were measured adjacent to the north window. Figure 2.8 shows the local buckling on the inside of the north wall near the location of maximum deflection. This building,

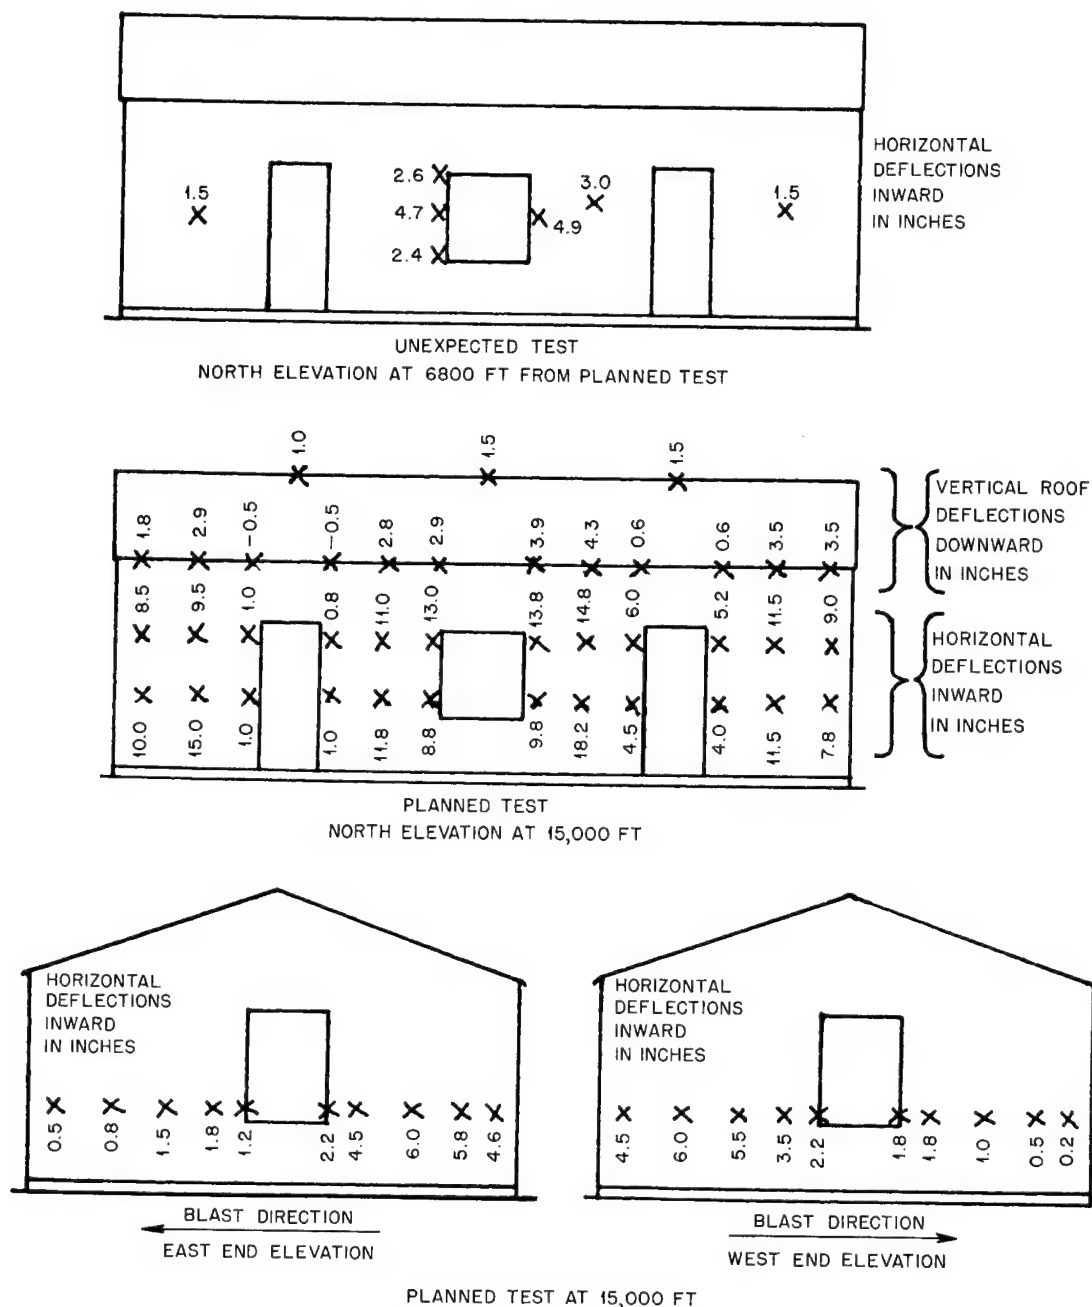
Fig. 2.7—Offset measurements of permanent wall and roof deflections in inches in Armco buildings that remained intact.

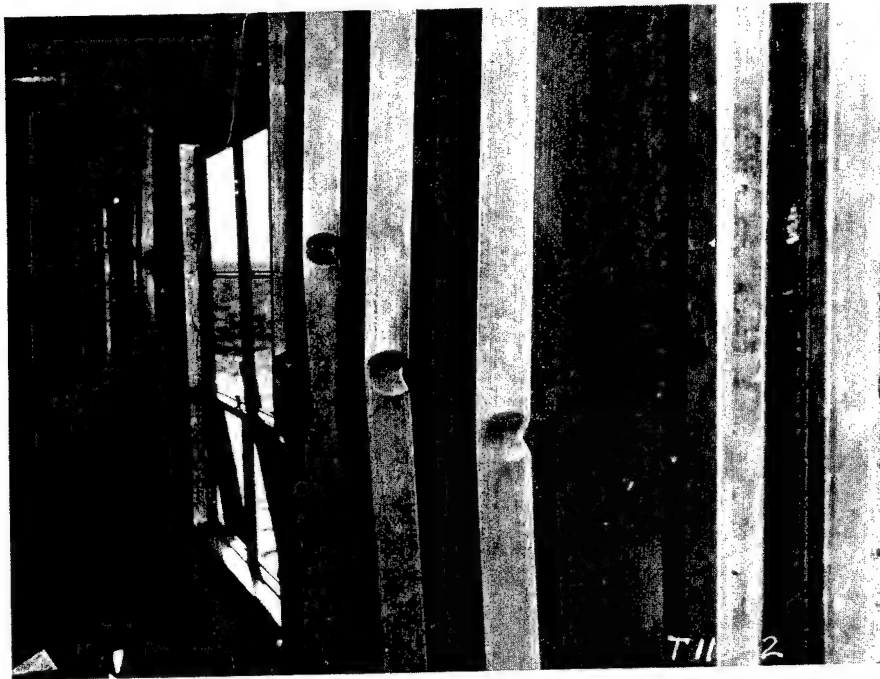
Fig. 2.8 — Interior view of damage to north wall of Armco Building 31.2-d1 from unexpected test.

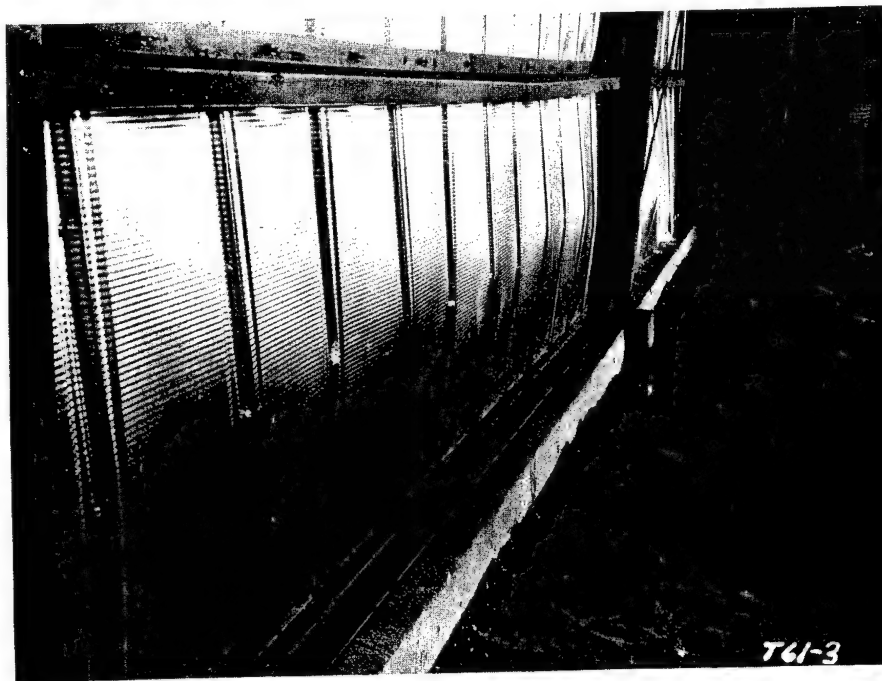
Fig. 2.9 — Interior view of wall damage in Reynolds-Butler Building 31.2-a2 from unexpected test.

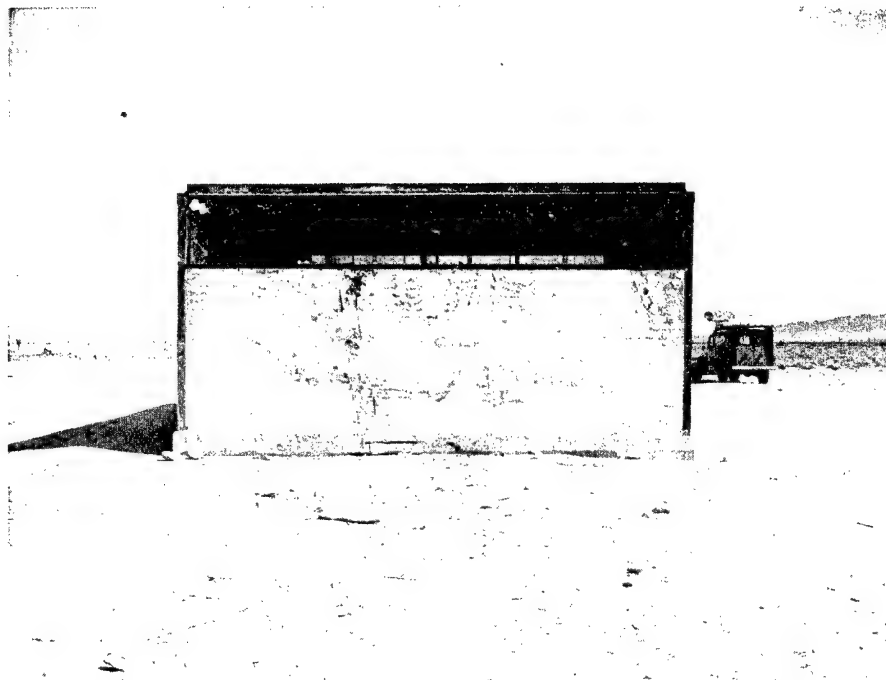
Fig. 2.10—North wall of Union Carbide building after planned test.

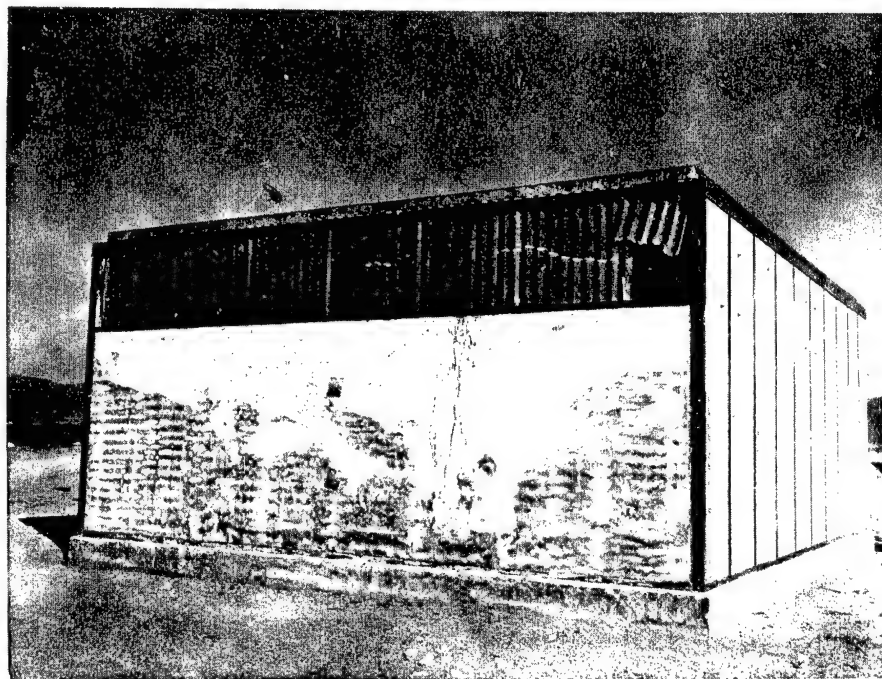
Fig. 2.11—South wall of Union Carbide building after planned test.

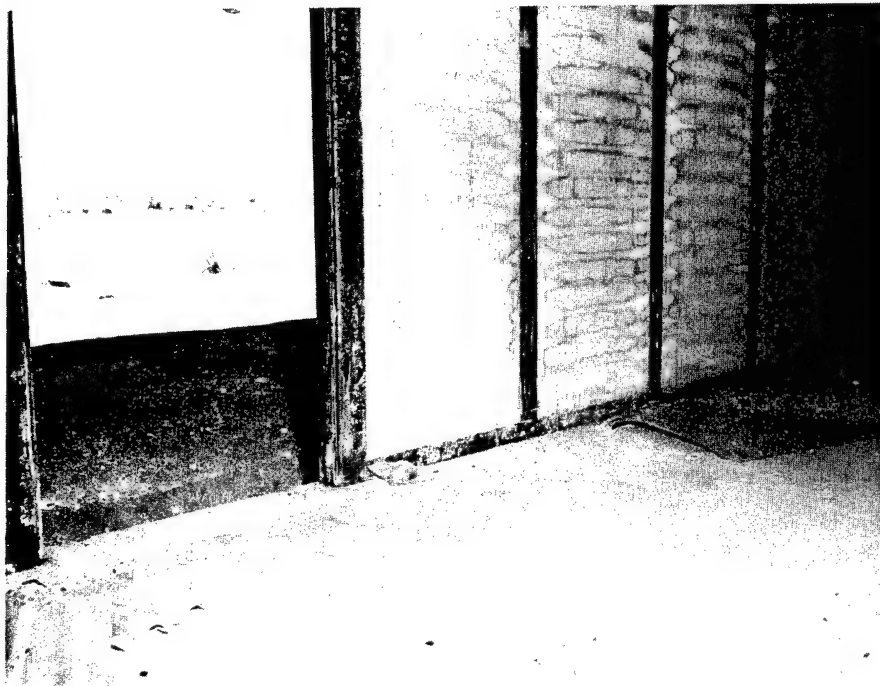
Fig. 2.12—Interior view looking out doorway of Union Carbide building after planned test.

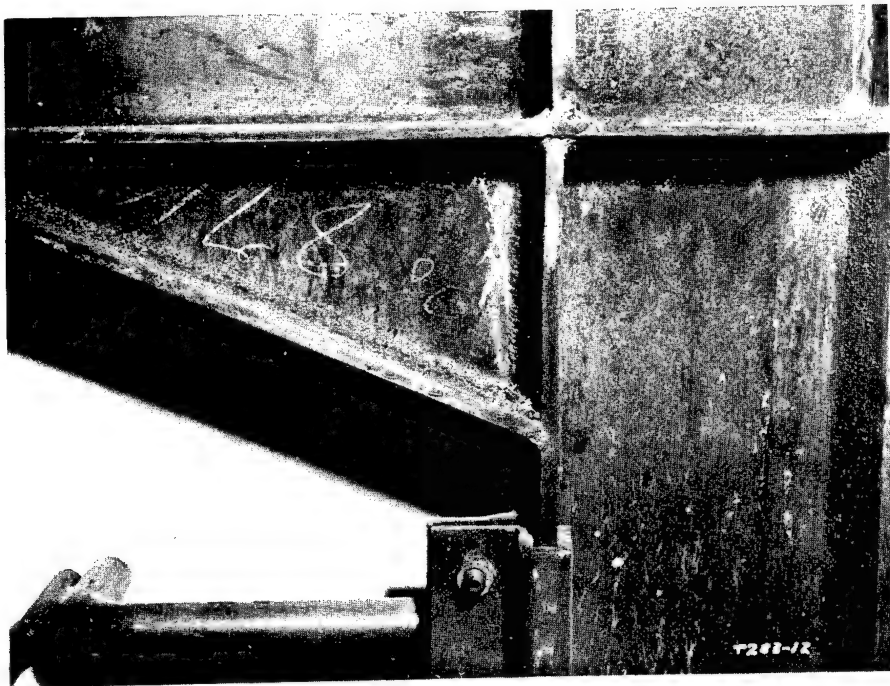
Fig. 2.15—Southeast corner frame connection of Union Carbide building.

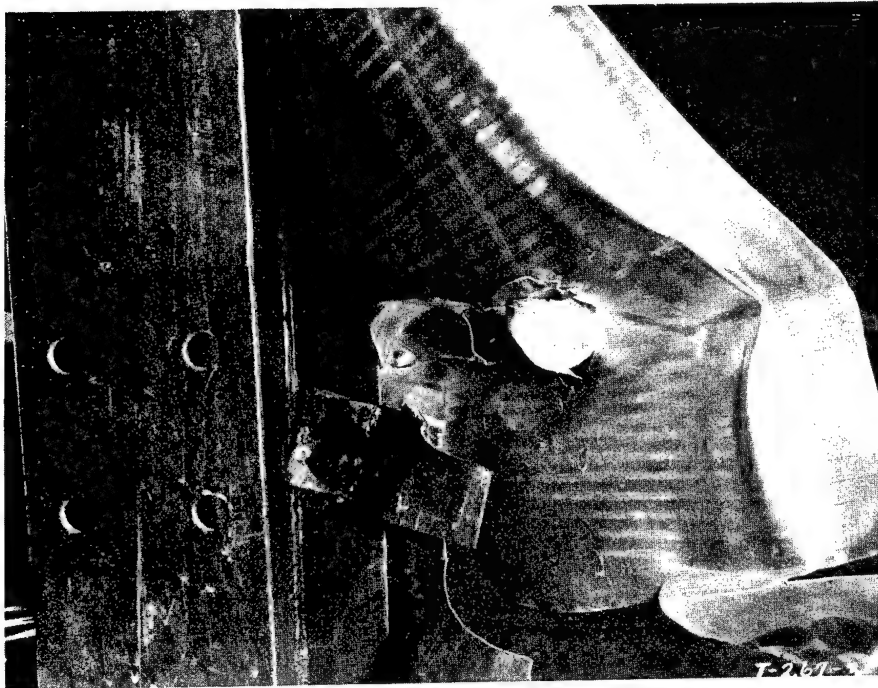
Fig. 2.21 — Interior detail of torn girt connector north of Reynolds-Butler Building 31.2-a1 after planned test.

Figure 2.21 shows the detail of a torn girt connector which is typical of the end failures of this member. Approximately one-half of the total girt area is cut away at this point to provide sufficient coping of the Z bar in order to eliminate interference between the exterior panel and the front face of the columns. The girt is then attached by a single $\frac{1}{2}$ -in.-diameter bolt passing through a slotted hole. Initially, the slotted hole permits a longitudinal movement of the girt which is resisted only by the friction between the bolt and the girt material. Then at the sharp internal cut, the girt starts to tear at the end. As it does so, the torn piece of girt that remains attached to the column is twisted almost 90° , as shown in Fig. 2.21. There is some information available on the strength of eccentrically loaded tension members of steel which fail by tearing that starts at one side, due to a notch or stress concentration, and information¹ is also available on the strength of bolts in shear. The fact that the bolts did not fail

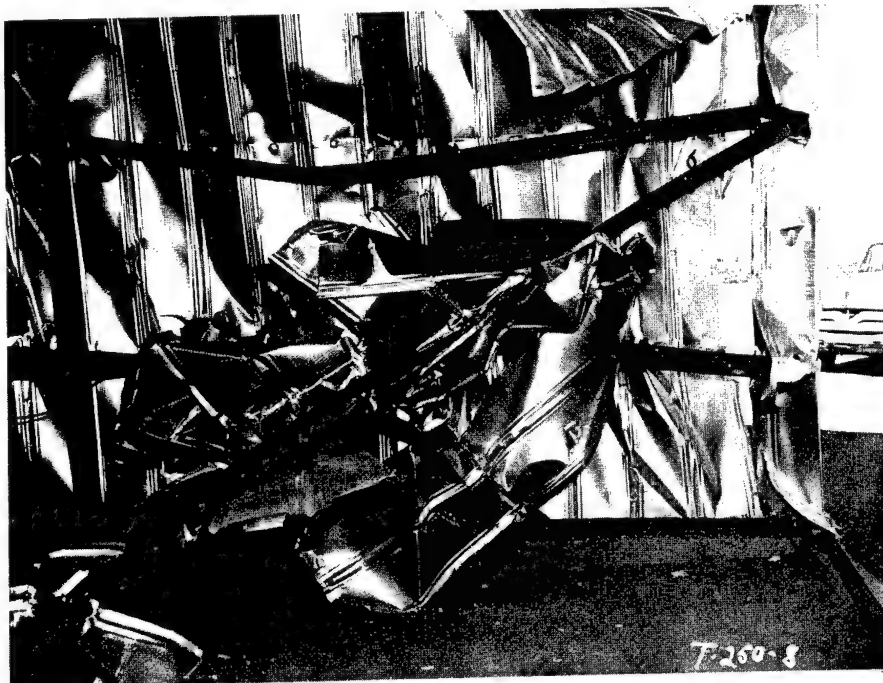
Fig. 2.22 — Interior view of Reynolds-Butler Building 31.2-a1 after planned test. (Note that west girts and panels of north wall have been thrown against west end.)

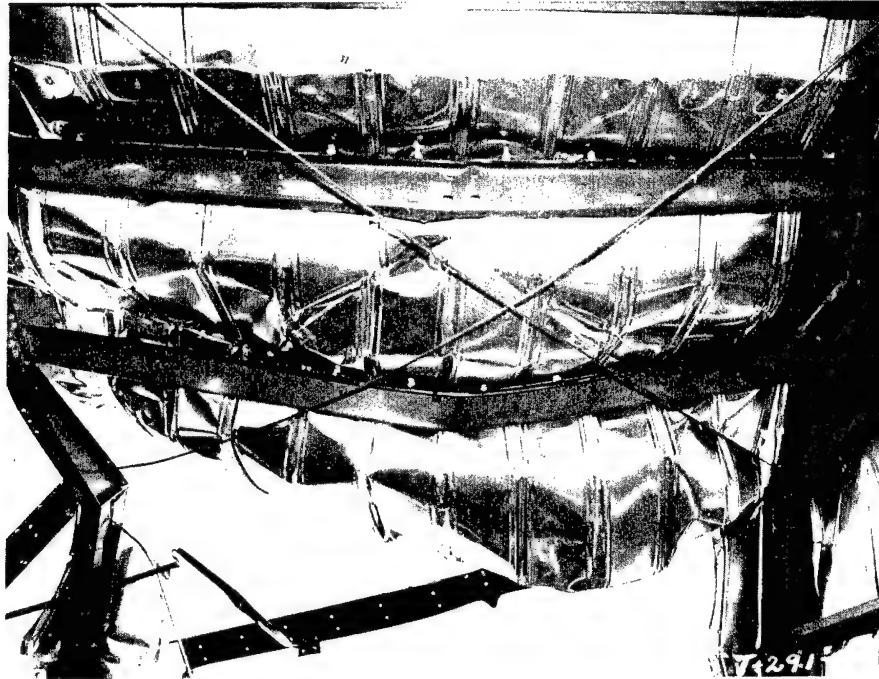
Fig. 2.23 —Roof purlins at northeast corner of Reynolds-Butler Building 31.2-a1 after planned test.

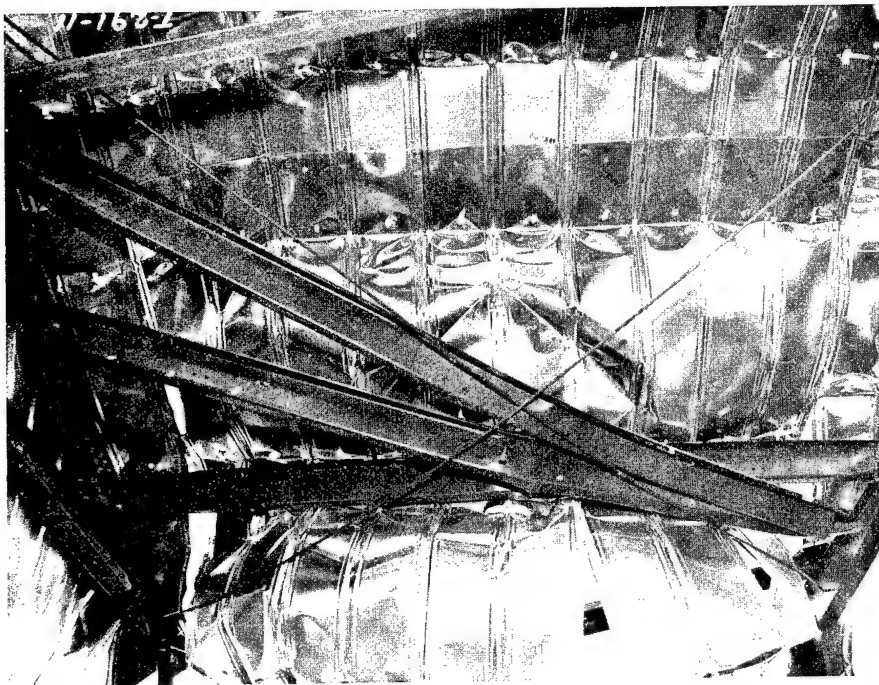
Fig. 2.25—Underside of roof at northwest corner of Reynolds-Butler Building 31.2-a1 after planned test.

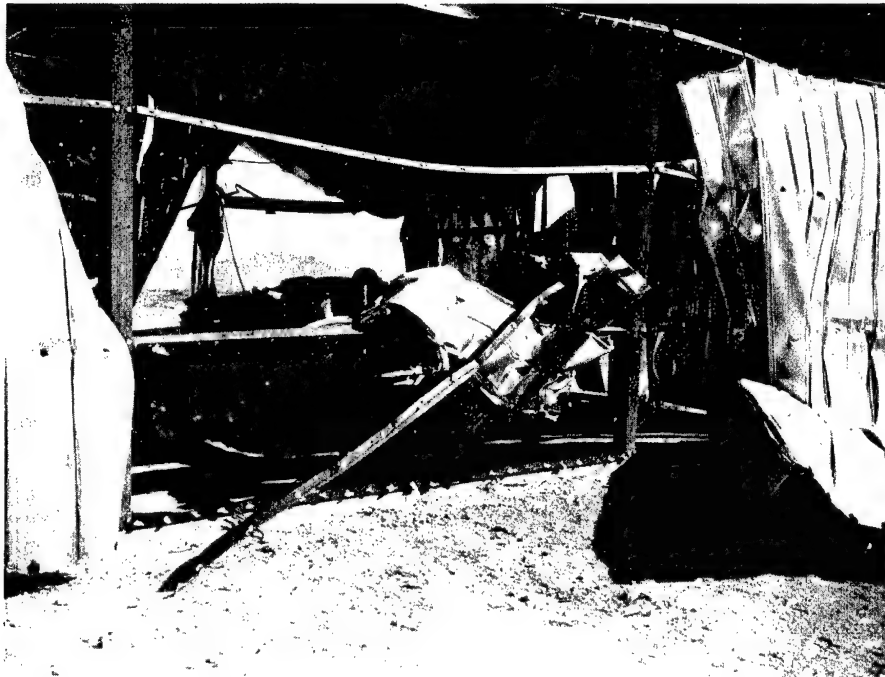
Fig. 2.27—North girts and siding blown through south wall of Reynolds-Butler Building 31.2-a1 after planned test.

shown in Fig. 2.27. They survived the experience of having the central wall girts and sheeting from the north wall blown against them after striking machinery within the building. Except along the ridge, the roof sheeting was largely detached from the purlins. The purlins on the south face of the roof were the least damaged of any sheet-supporting members, as shown in Fig. 2.28, a view looking upward at the east space of the south roof face.

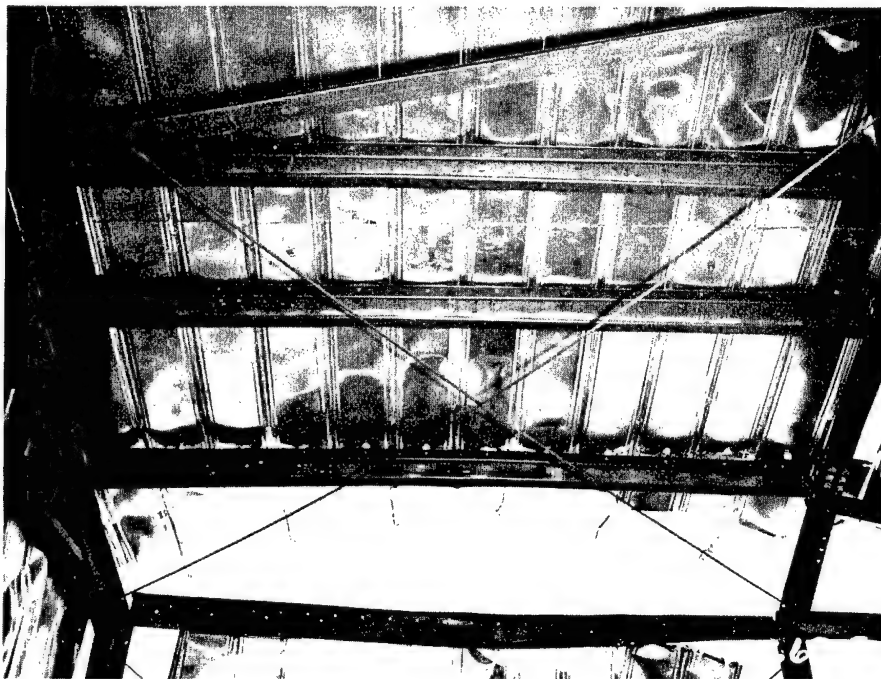
Fig. 2.28—Underside of southeast roof section of Reynolds-Butler Building 31.2-a1 after planned test.

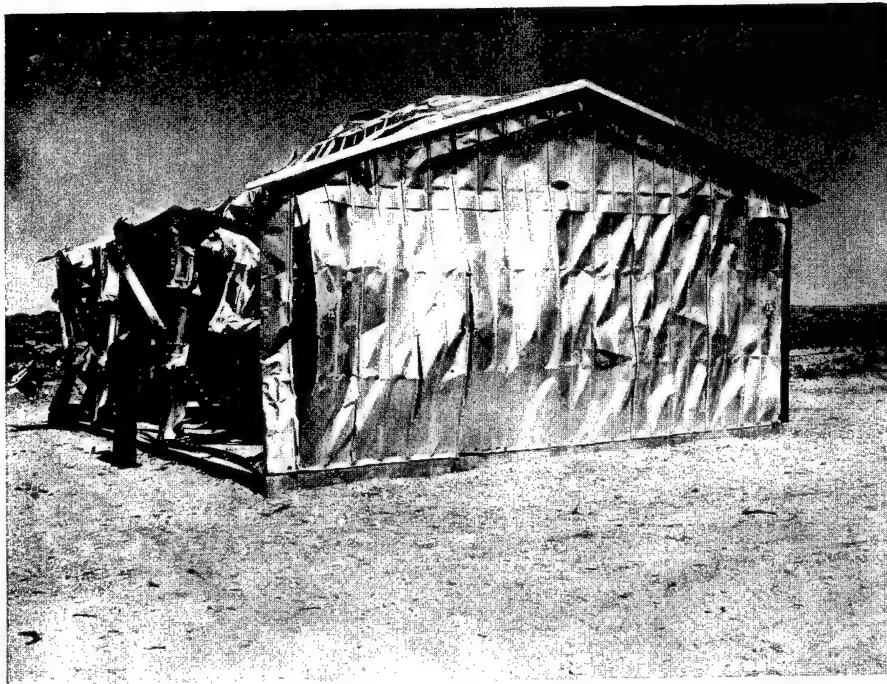
Fig. 2.29 — West end of Reynolds-Butler Building 31.2-a1 after planned test.

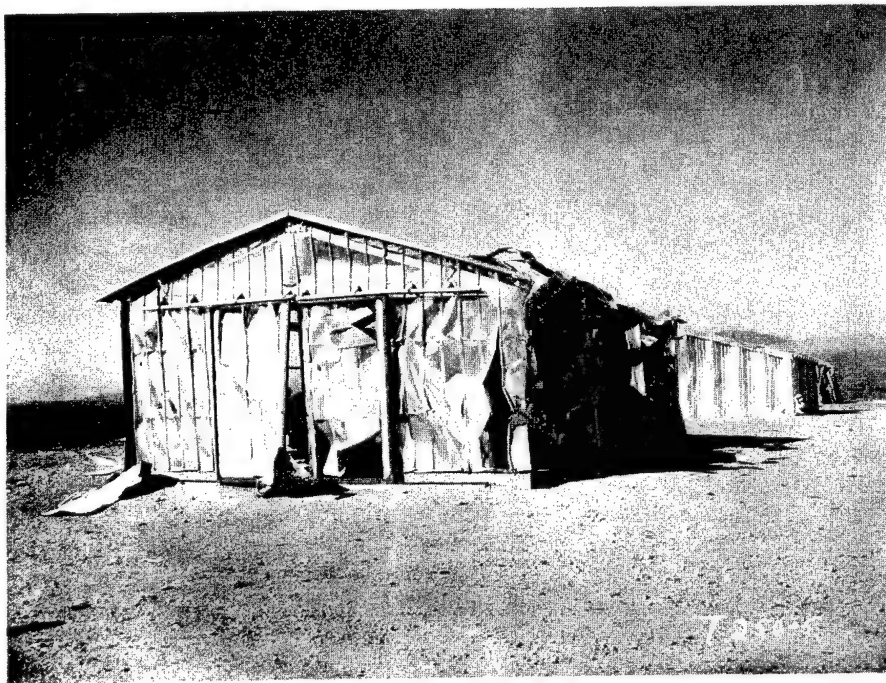
Fig. 2.30 — East end of Reynolds-Butler Building 31.2-a1 after planned test.

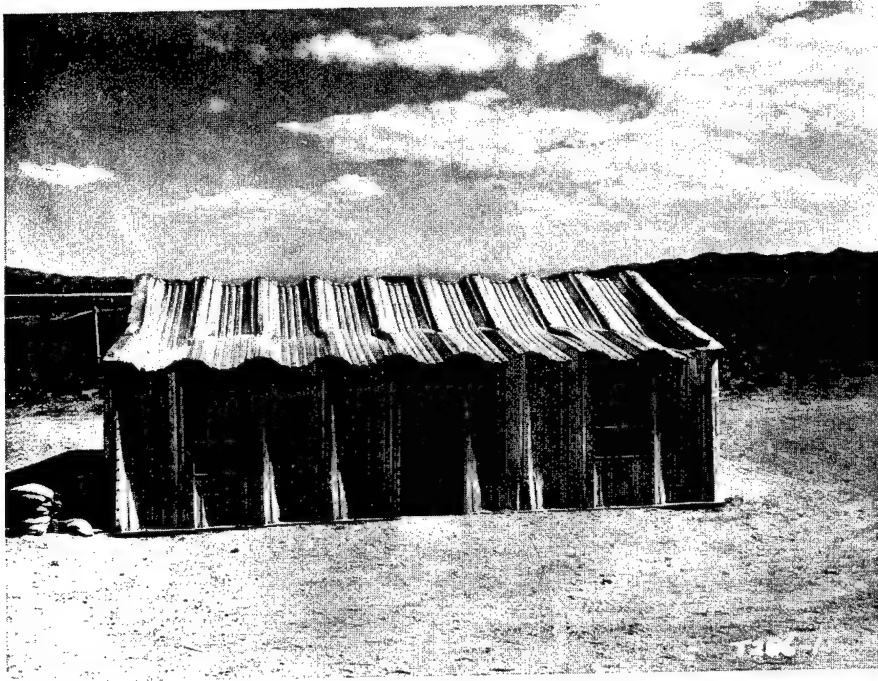
This building, at 6800 ft, was practically destroyed; the roof collapsed and rested at the center on machinery within the building. Front wall segments were wrapped around the machinery, and this provided a block that at least partially prevented additional movement of building wreckage in the downblast direction.

Fig. 2.31 —North side of Behlen Building 31.2-b1 after planned test.

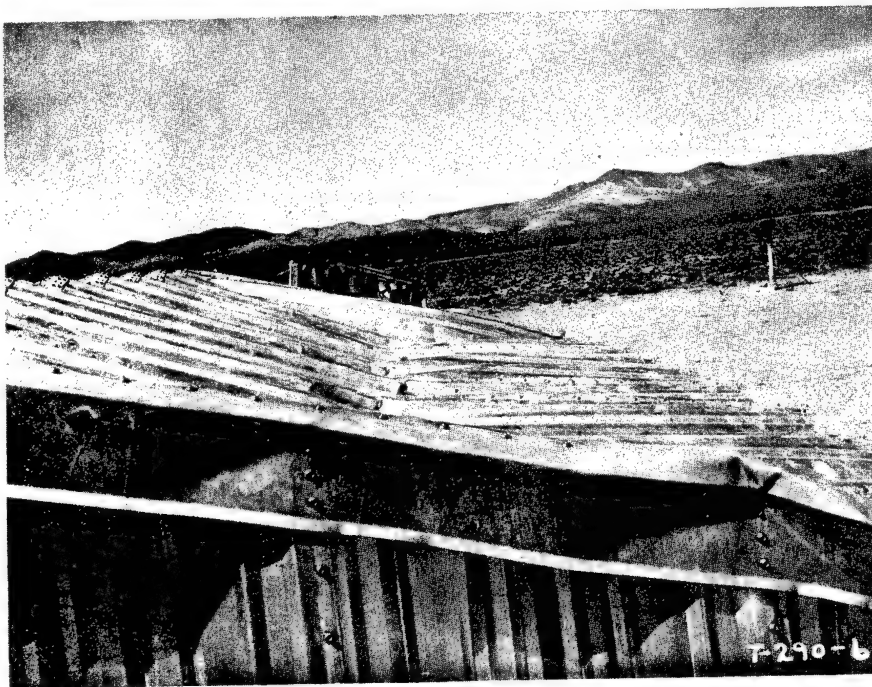
Fig. 2.32 —View looking along north roof of Behlen Building 31.2-b1 after planned test.

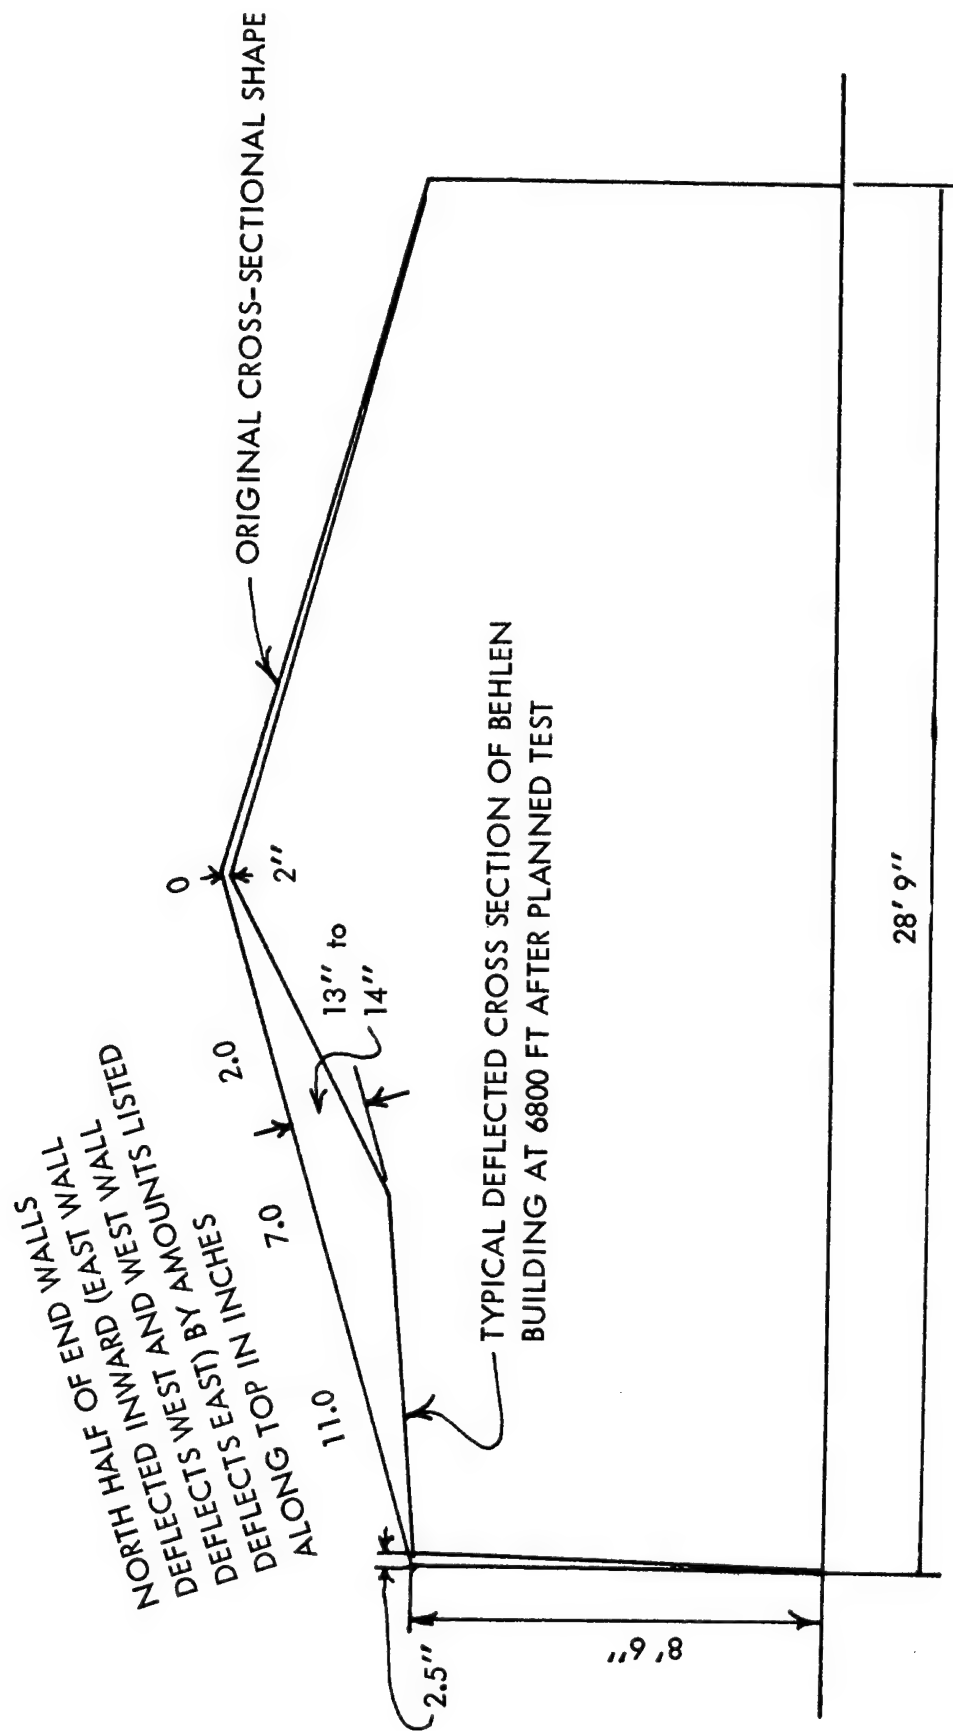
Fig. 2.33 — Permanent deflection of Behlen Building 31.2-b1 at 6800 ft after planned test.

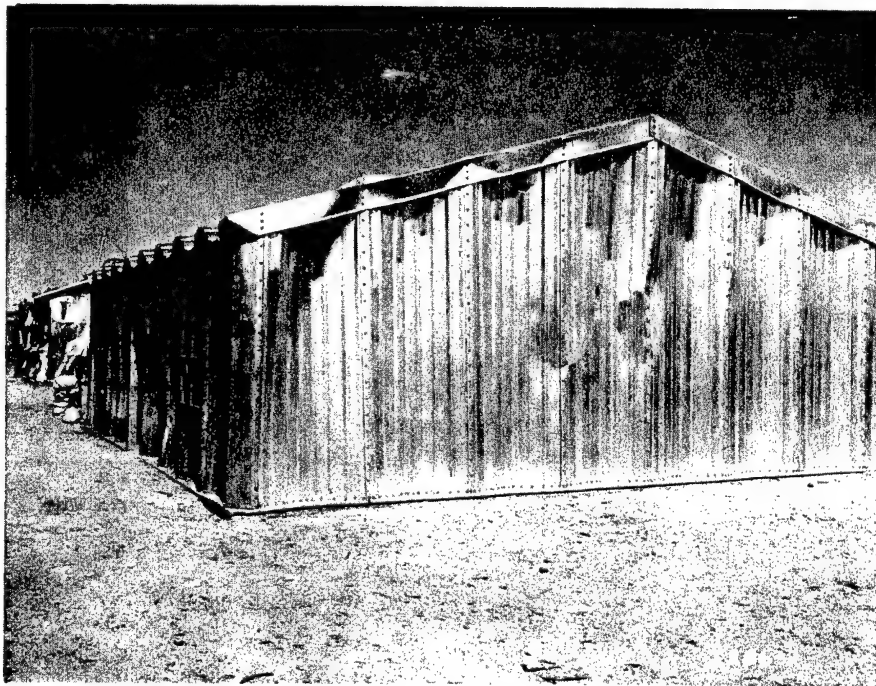
Fig. 2.34 — West end of Behlen Building 31.2-b1 after planned test.

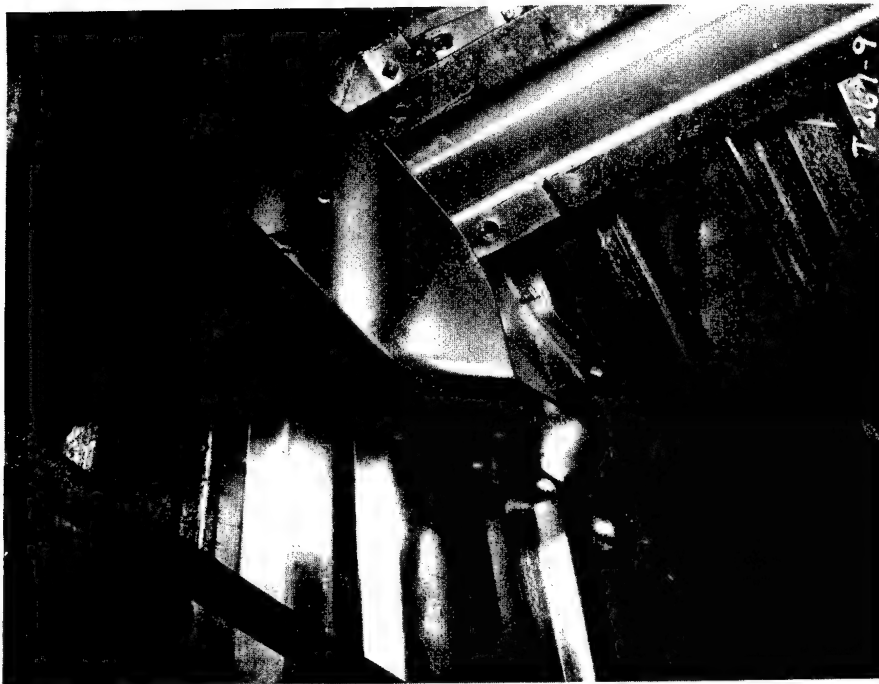
Fig. 2.36—Interior ridge detail at west end of Behlen Building 31.2-b1 after planned test.

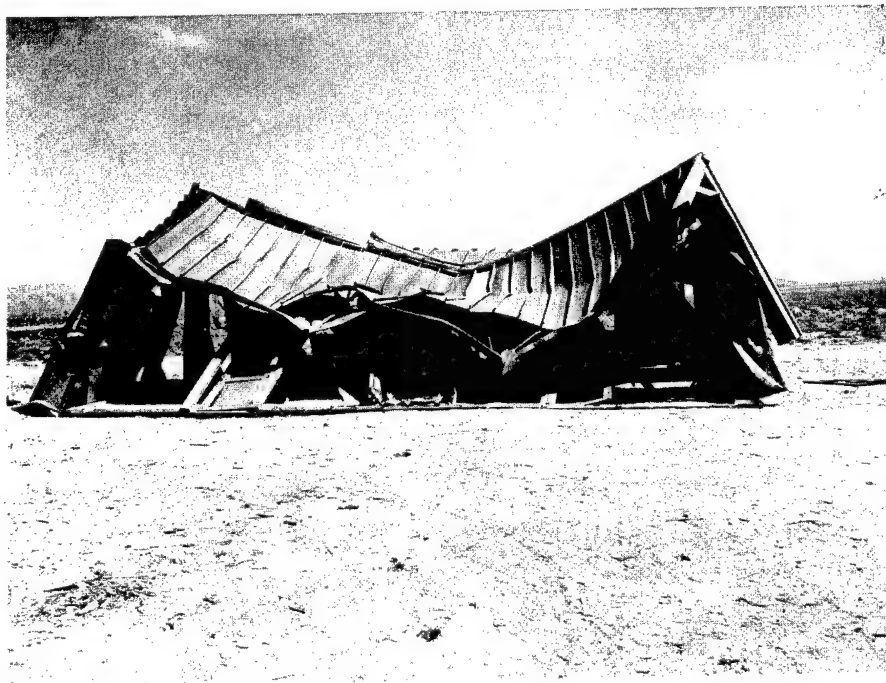
The north side of the building is shown in Fig. 2.37, which also indicates the sag in the roof. Figures 2.38 to 2.41 show various views of the crumpled ends and the south side of the building. Most of the wall segments remained on site, although the wall panels along the north side were largely torn loose from the wall sill connections, as shown in detail in Fig. 2.42, and one piece swept downblast about 50 ft. At the southwest corner of the building, the sill was also torn loose, as shown in Fig. 2.43. The wall paneling remained attached to the sill along 75 per cent of the east end and all the west end.

Fig. 2.37—North side of Armco Building 31.2-d1 after planned test.

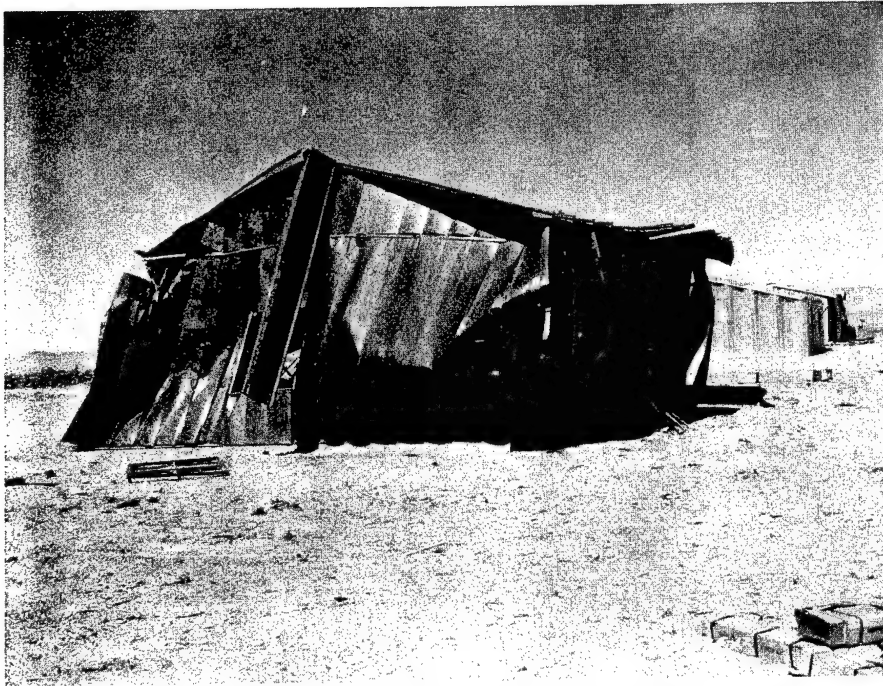
Fig. 2.40 — West end and south side of Armco Building 31.2-d1 after planned test.

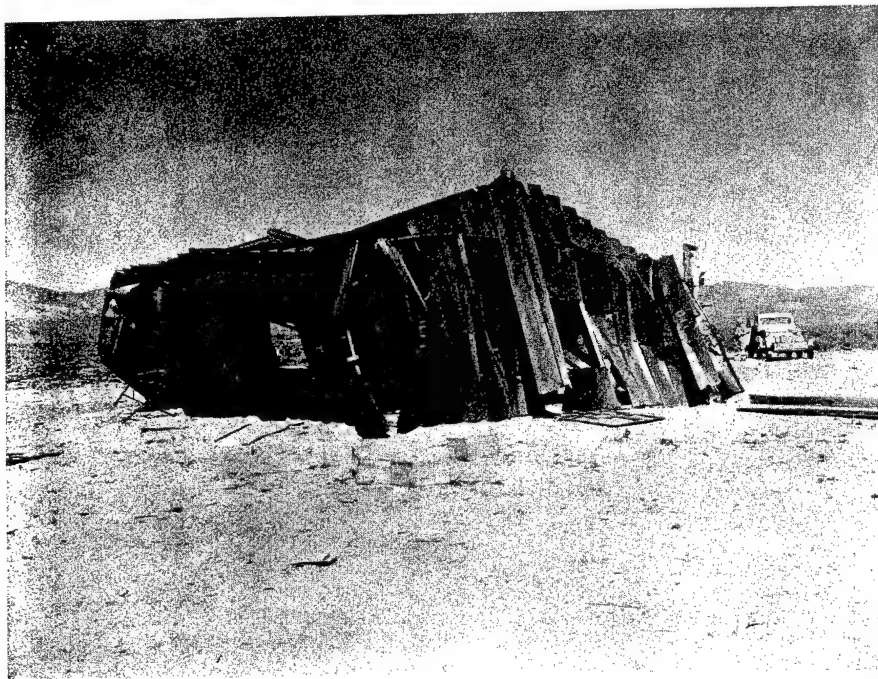
Fig. 2.41 — East end and south side of Armco Building 31.2-d1 after planned test.

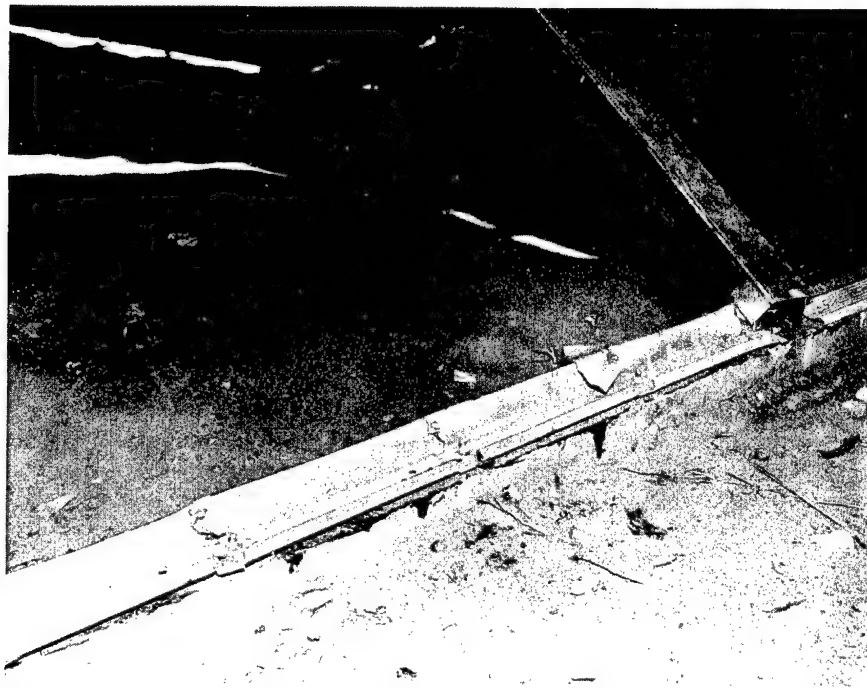
Fig. 2.42—Sill along north wall of Armco Building 31.2-d1 after planned test.
